Aesthetic Repair of Zirconia Supported Porcelain Prosthesis with Ceramic Veneer: A Case Report with Three-Year Follow-up

CASE REPORT

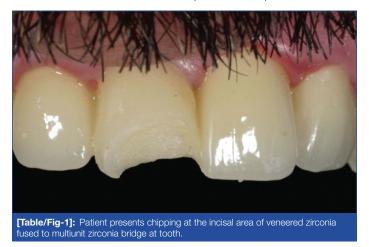
A 38-year-old male patient visited a private dental office with complaints of fractured tooth which occurred two days back, in a four unit porcelain veneered zirconia FPD, which was delivered one year ago. The FPD was located between upper right and left second incisors. After the oral examination, it was observed that the fracture was in the ceramic fragment of the right central incisor [Table/Fig-1]. All treatment options regarding the porcelain chipping (porcelain fracture without zirconia framework exposure) were explained to the patient. The patient refused to renew his FPD due to clinical time and cost. Patient approved of ceramic veneer, as it would be more aesthetic than to repair with composite resin.

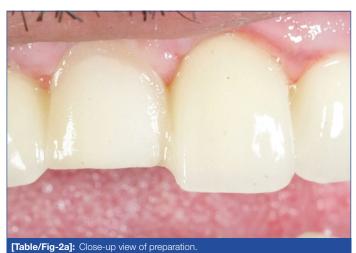
The labial surface of the right central incisor was prepared with a tapered, round end diamond bur (Meisinger, Hager and Meisinger GmbH, Dusseldorf, Germany) under water coolant until a flat surface was obtained on the ceramic. All sharp edges and corners were smoothened. Chamfer marginal finish line was prepared in order to avoid stress build-up [Table/Fig-2a,b].

[Table/Fig-2b]: Prepared porcelain in tooth 11.
