Retrieval of a Cold Welded and Damaged Gingival Former: A Clinical Tip

Keywords: Cold weld, Gingival former retrieval, Implants, Prosthesis, Screw driver

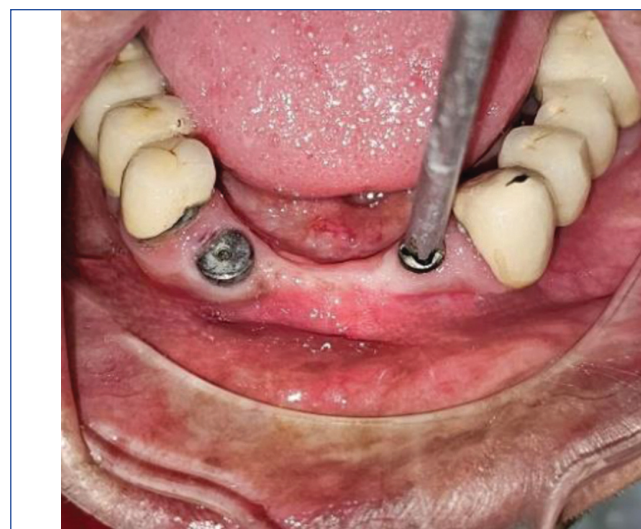
[Table/Fig-3]: Snugly fitted screwdriver with modified gingival former.

The gingival former was modified until the beak of the screwdriver fit snugly into the plus-shaped groove [Table/Fig-3]. Utmost care was taken during the grooving process, as excessive removal of the structure could lead to failure in fitting the screwdriver [Table/Fig-4].

The gingival former was modified until the beak of the screwdriver fit snugly into the plus-shaped groove [Table/Fig-3]. Careful attention was given during the grooving process, as excessive removal could result in failure to fit the screwdriver properly.

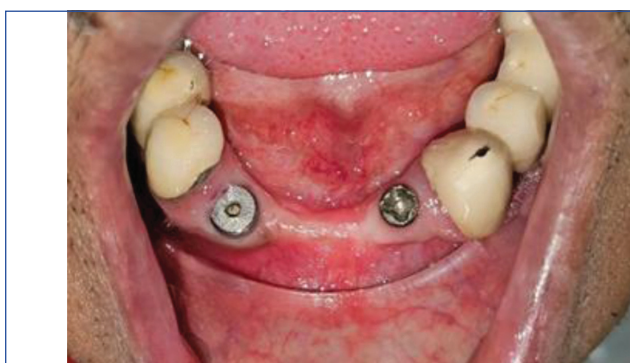
Initially, a hex driver was used for the retrieval of the gingival former. During the removal process, it was noticed that the threads in the access hole of the gingival former in the region of 33 were irreversibly damaged due to excessive torque applied by the previous dentist, which led to cold welding and failure to engage the hex driver. Various methods, such as reverse torquing and ultrasonic retrieval techniques, were attempted but proved ineffective [1].

[Table/Fig-1]: Plus-shaped groove made on the gingival former using a carbide bur [2].

Using a high-speed handpiece and a carbide bur, a plus-shaped groove approximately 2 mm in depth was created from the center by extending the access hole of the former under copious irrigation until the screwdriver fitted snugly [Table/Fig-1] [2]. A high vacuum suction was employed to prevent any particles of the former from being swallowed by the patient. The screwdriver from the Typodont jaw set was autoclaved before use in the patient's mouth [Table/Fig-2].

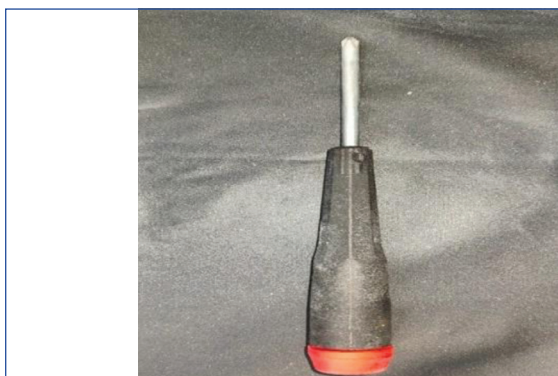
[Table/Fig-2]: Screw driver used for the retrieval of former.

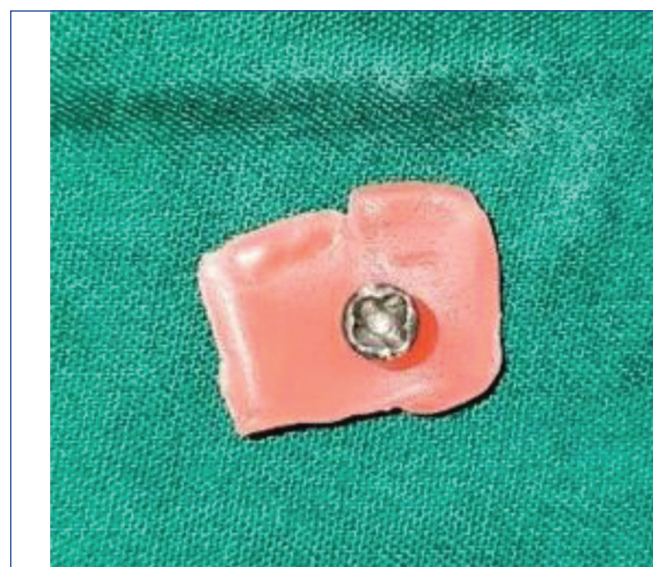
[Table/Fig-4]: Retrieved gingival former.

Cold welding is an unusual and rare mechanical complication that can occur following second-stage implant surgery. Cold welding happens when dried blood and bone fragments remain on the surfaces of implant components. Tension builds up in the screw due to excessive tightening and the first load produced by applying torque is known as preload. This results in the elongation of the

screw [3]. An excessive clamping force forms between the implant and the gingival former because of this preload. Large amounts of preload have been shown to result in plastic deformation or a permanent alteration of the material, which is frequently referred to as cold welding, ultimately leading to the screw becoming unretrievable.

Once the former was retrieved [Table/Fig-4], an implant-level impression was recorded using putty and light body material and a new gingival former was placed [Table/Fig-5]. The final prosthesis was delivered to the patient in accordance with the principles of implant-protected occlusion [Table/Fig-6].

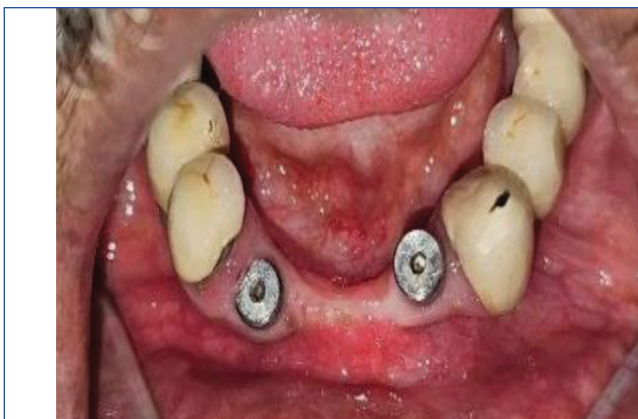
[Table/Fig-5]: New gingival former placed after making impression.

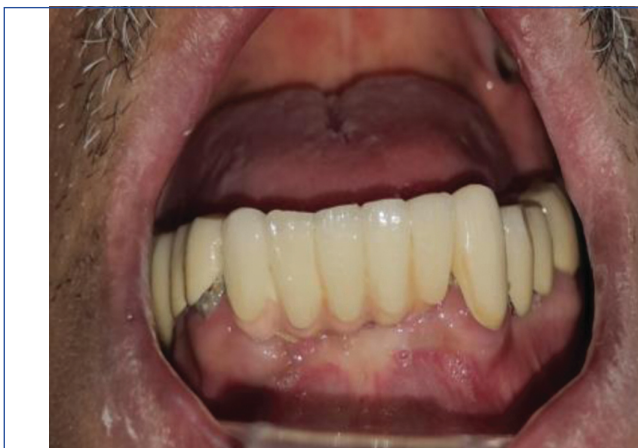
[Table/Fig-6]: Final prosthesis.
