Surface Morphology and Microbial Profile of Failed Peri-implantitis Affected and Clinically Healthy Dental Implants: A Comparative Cross-sectional Study

Aim: To compare the surface morphology and microbial load of failed peri-implantitis affected implants with clinically healthy implants using Scanning Electron Microscopy (SEM) and culture-based microbiological analysis.

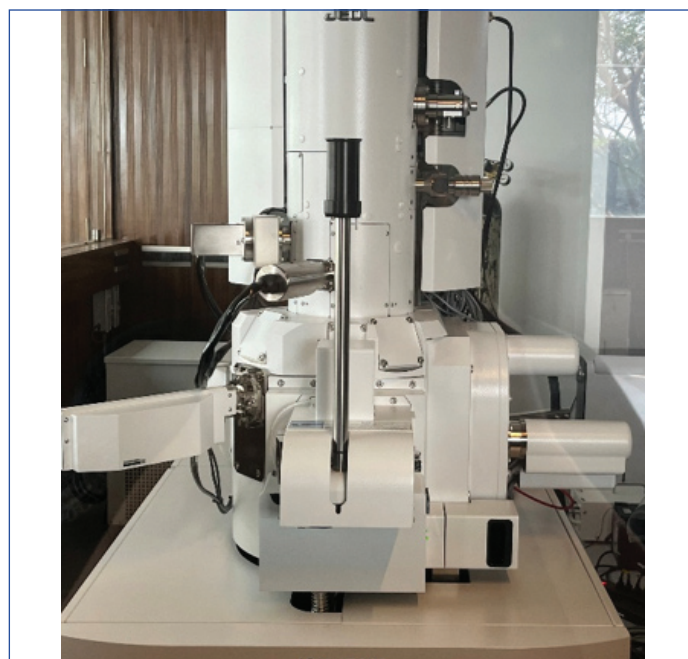
[Table/Fig-1]: Scanning electron microscope.

Surface topography analysis: Surface topography was examined using a JEOL Scanning Electron Microscope (JEOL JSM-IT800; JEOL USA, Peabody, MA) equipped with a Gemini column, offering a resolution of 1.5 nm [Table/Fig-1]. Before imaging, implants were sputter-coated with a thin gold layer (5-10 nm) under vacuum (approximately 0.05 mbar, 20 mA, 30-60 seconds) to improve conductivity and reduce charging. SEM evaluation was performed in high-vacuum mode at an accelerating voltage of 10 kV, with a working distance of 11.2 mm and a magnification of $\times 1000$. Surface morphology was captured using an SE2 detector. An unused implant of the same brand was included as a structural reference for baseline surface morphology rather than as a clinical control for comparison with healthy implants.

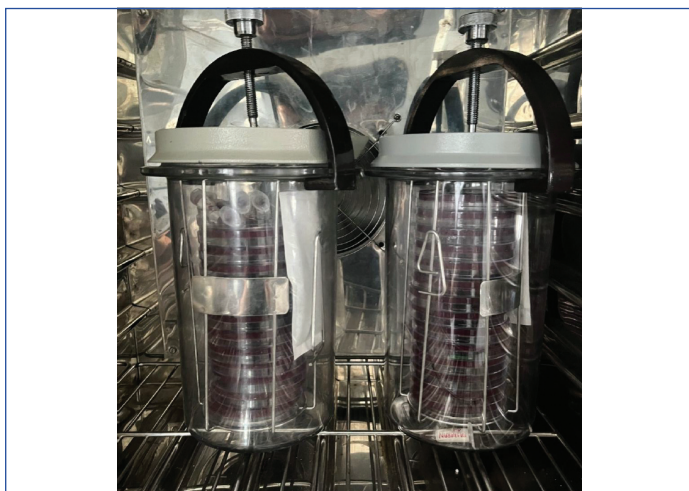
[Table/Fig-3]: Anaerobic jar with gas-pack system for oxygen-free incubation of blood agar plates for anaerobic culture.

For anaerobic culture, plaque samples were placed in blood broth and stored at 4-8°C until processing. The samples were lawn-inoculated on blood agar plates and incubated in an anaerobic jar using a gas-pack system to achieve an oxygen-free environment [Table/Fig-3]. The plates were incubated at 37°C for seven days, after which CFUs were recorded and expressed as CFU/mL. All media were verified for sterility, and strict quality control measures were followed to ensure accuracy and reproducibility throughout the microbiological procedures.

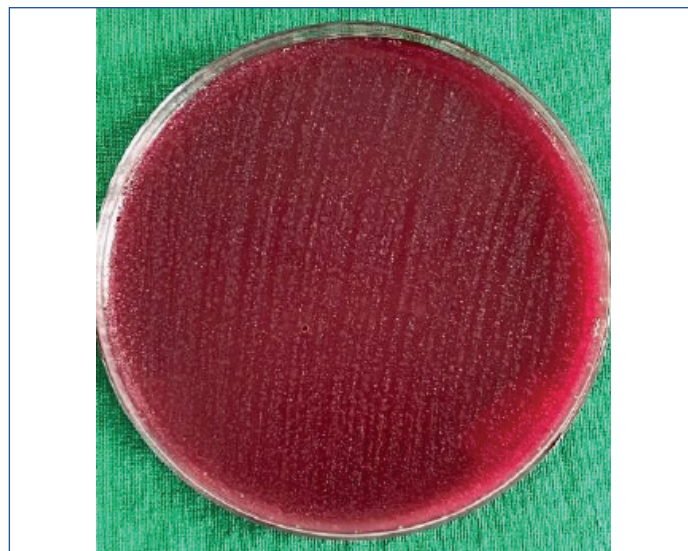
[Table/Fig-10]: Anaerobic culture of failed peri-implant site.

The microbiological analysis demonstrated a significant difference in bacterial load between the control and test sites. For aerobic cultures, the mean CFU/mL was $2.23 \pm 0.06 \times 10^6$ in the control group [Table/Fig-7] and $6.61 \pm 1.02 \times 10^6$ in the test group [Table/Fig-8], yielding a t-value of 13.56 and a p-value of <0.001, indicating a highly significant increase in aerobic bacterial load at diseased sites. Similarly, anaerobic cultures showed a mean CFU/mL of $1.02 \pm 0.03 \times 10^6$ in the control group [Table/Fig-9] compared with $3.96 \pm 0.91 \times 10^6$ in the test group [Table/Fig-10], with a corresponding t-value of 10.21 and a p-value of <0.001, confirming a statistically significant elevation of anaerobic bacterial load in diseased peri-implant sites [Table/Fig-11].
