# Effect of Instrumentation Length and Instrumentation Systems: Hand Versus Rotary Files on Apical Crack Formation – An In vitro Study

## ABSTRACT

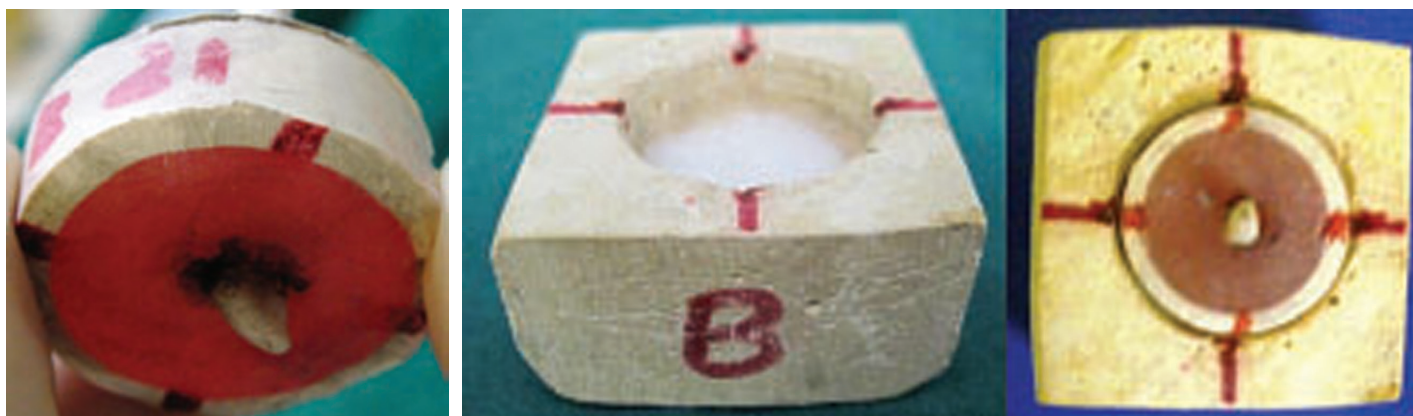
**[Table/Fig-1]:** Specimen after periodontal ligament simulation with apex exposed for recording images. **[Table/Fig-2]:** Customised jig for placement of specimens under stereomicroscope.

to provide a stable reference point. A customized jig cuboidal in shape with central space for specimen placement was fabricated with dental stone [Table/Fig-2]. Reference markings were made both onto the jig and specimens. Specimens were placed in a way that the markings on them coincided with that of jig.

material [20]. Silicone being rubber like elastomeric impression material allowed the root to move in a limited space mimicking physiologic tooth movement and avoided external reinforcement. Customized jig facilitated orientation of specimens at exactly same angulations in apical, mesial and distal aspects every time. Thus, preoperative and postoperative images of root apices could be recorded at exactly same position for comparison of occurrence of cracks.

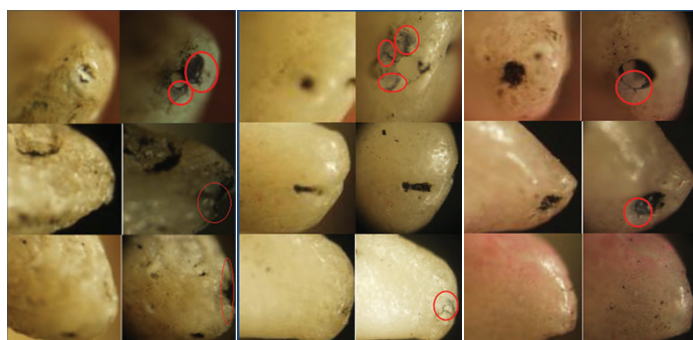
(Images left to right)

**[Table/Fig-5]:** Representative pre and postoperative images of cracks formed after instrumentation with K- files at WL-apical, mesial and distal aspects respectively.

**[Table/Fig-6]:** Representative pre and postoperative images of cracks formed after instrumentation with RaCe files at WL-apical, mesial and distal aspects respectively.

**[Table/Fig-7]:** Representative pre and postoperative images of cracks formed after instrumentation with K3 files at WL-apical, mesial and distal aspects respectively.

In Group I and II, instrumented with K-files, cracks were seen in 40% of the teeth at WL and 20% of the teeth at WL-1 [Table/Fig-5]. Statistical analysis showed no significance in the number of cracks formed when instrumented to WL or WL-1. Though straight roots were used in this study, it is known that the apical foramen is often eccentrically located from anatomical or radiographic apex in 68 to 80% of the teeth [22]. These deviations in apical foramen indicate that even in straight roots, canals can curve apically and are not perfectly straight. In fact, all root canals have some degree of curvature [23]. Stainless steel K-files are stiffer files and thus, can cause more stresses compared to the more flexible rotary NiTi files. This could be the reason for statistically non significant results with stainless steel hand files.

In Group III and IV, instrumented with rotary NiTi RaCe files, cracks were seen in 60% of the teeth at WL and in 10% of the teeth at WL-1 [Table/Fig-6].

In Group V and VI, instrumented with rotary NiTi K3 system, cracks were seen in 40% of the teeth at WL [Table/Fig-7]. No cracks were seen when instrumented at WL-1.
